Lower Iliuliuk River Restoration and Management Plan

Prepared for:
City of Unalaska

Prepared by:
PND Engineers, Inc.

January 2015

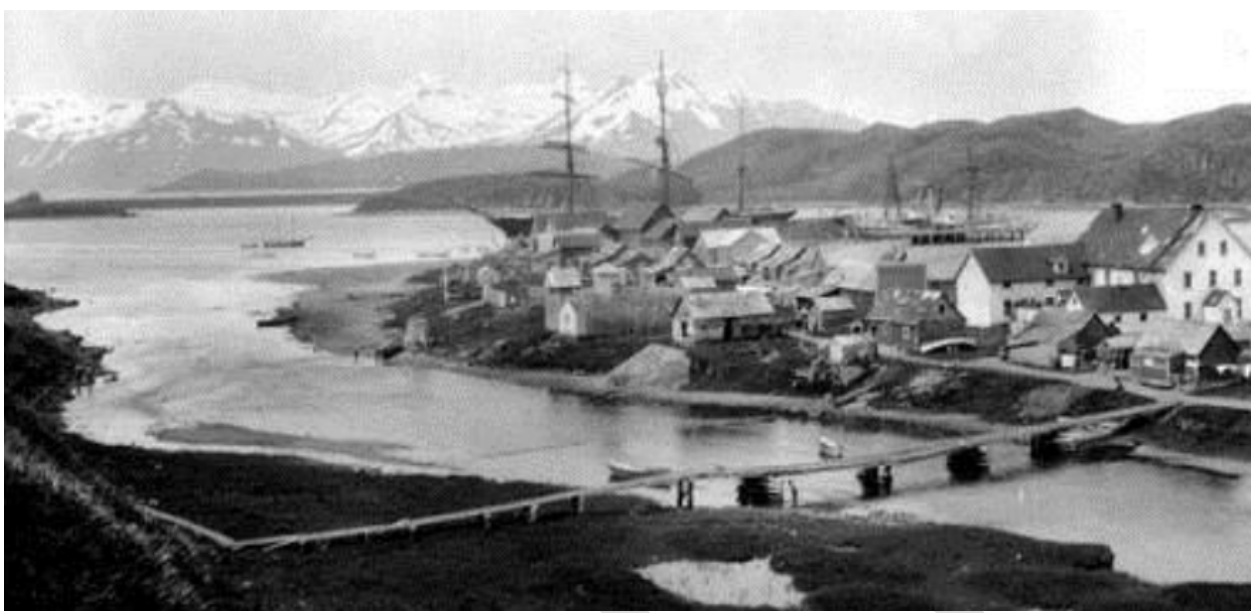
Photo 1-1. Historical Photo of the Mouth of the Iliuliuk River (courtesy of Jeff Hancock's public comment)

The north bank, within the project area, primarily consists of World War II road embankment. Road fill was observed underneath the vegetated mat. Based on historical photographs, it appears that vegetation has established on top of the gravel fill on its own. Photo 1-1 is a historical photo of the Iliuliuk River mouth prior to road construction, and filling of the north bank, and Photo 1-2 displays a photo taken in 2014 of the same area.

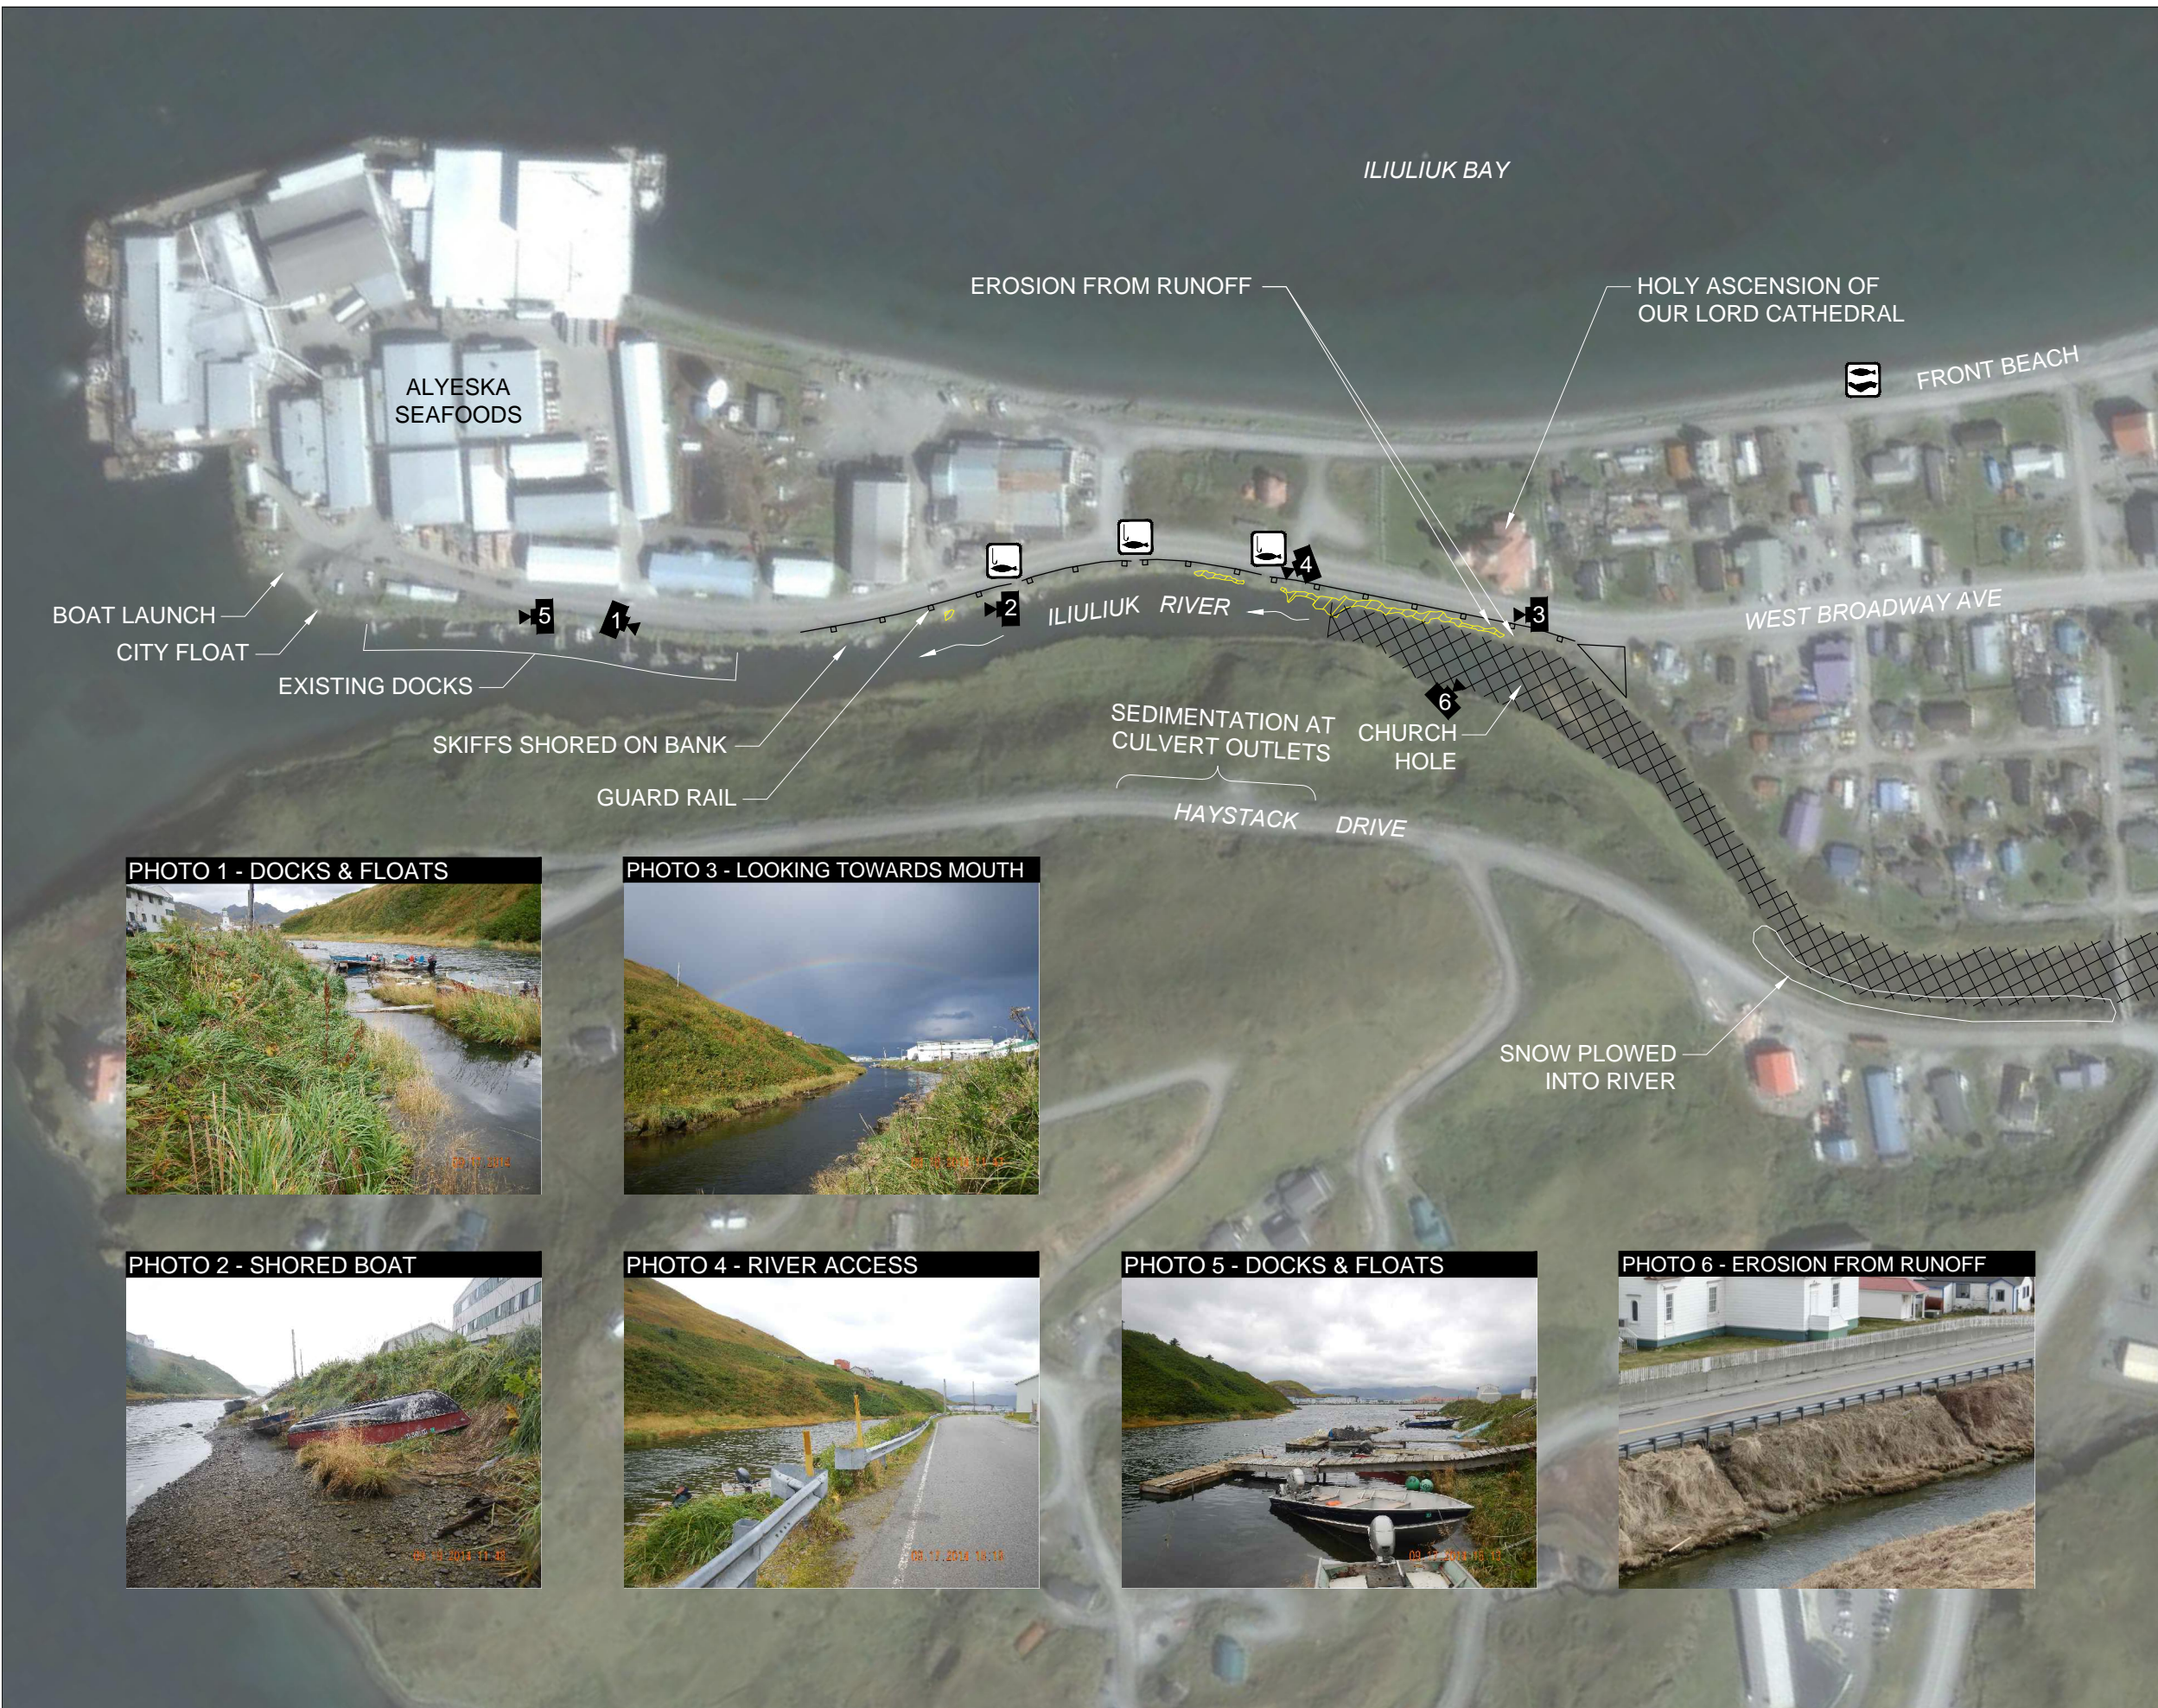
FIG 1-1

LOWER ILIULIUK RIVER
RESTORATION & MANAGEMENT PLAN
PROJECT AREA

During the September reconnaissance visit, PND conducted a wetlands study along the north lower 1,500 feet of bank. As previously mentioned, the majority of the bank slope consists of very steep road fill covered with a shallow vegetated mat. Wetlands were found only in certain locations directly adjacent to the river on a flat or shallow slope where vegetation could grow (shown in Figure 1-1). A full wetlands delineation report is attached in Appendix A.

Fishing for salmon along the lower river is only legal downstream of the previously mentioned sign (this point is shown in Figure 1-1), and fishing for sockeye salmon is not allowed at any location within the watershed. People were observed fishing, standing on the flat portion of the bank adjacent to the river, sometimes within wetlands. Often, fishermen were observed near openings in the guardrail where there is easy access to the riverbank (see Photo 2-4). Public comments also indicated users also fish from the top of the bank just behind the guardrail.

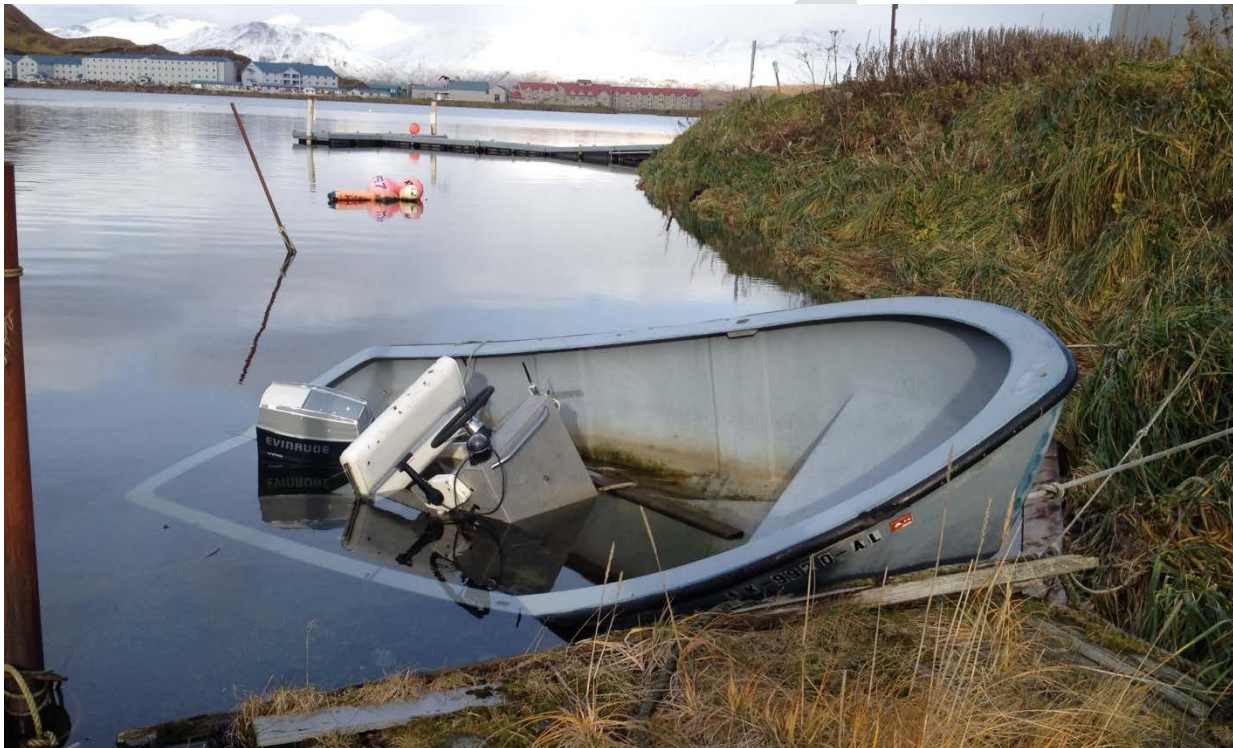
Photo 2-1. Abandoned Boat near Mouth of the Iliuliuk River

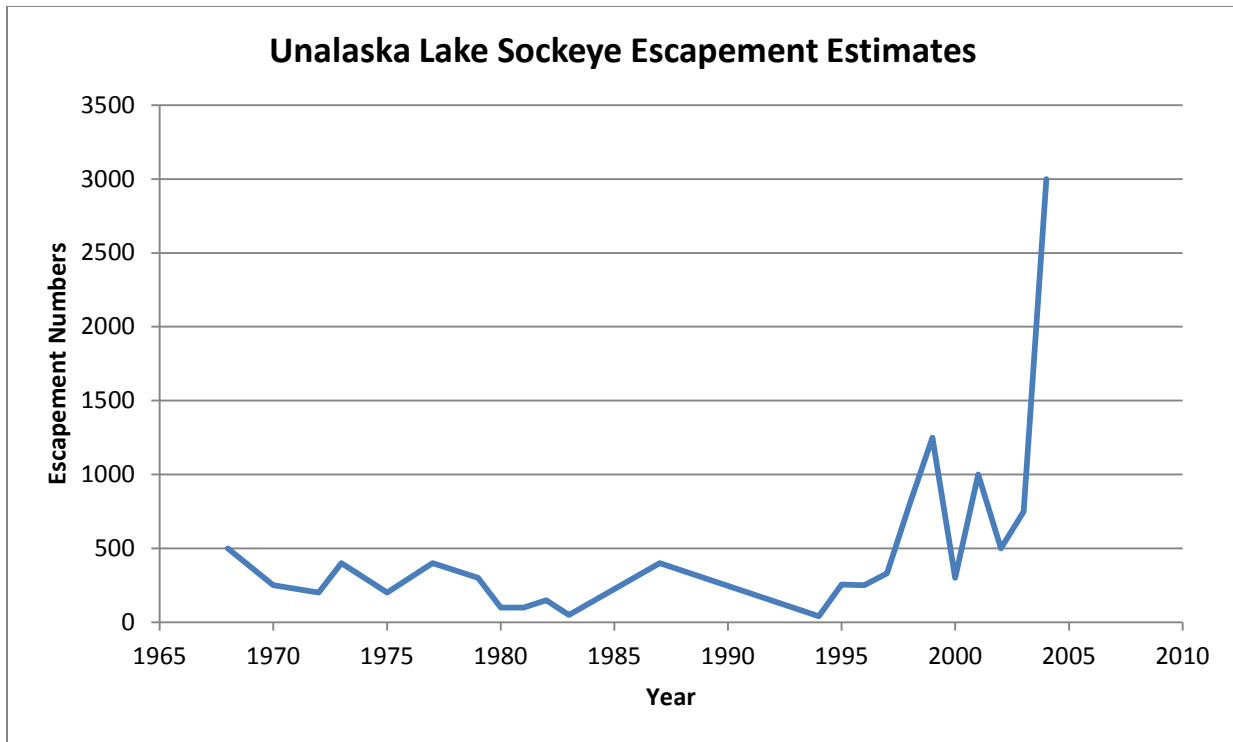
Figure 2-1. Unalaska Lake Sockeye Escapement Numbers (Tschersich 2007)

According to Holmes (1997) salmon runs at Unalaska Island have declined since the later 1980s. The cause is unknown; however, some speculation is that scouring due to large floods may be a factor. “The stock of sockeye which used to spawn in the inlet stream to Unalaska Lake was essentially eliminated after the flood [during the winter of 1984-85]”. However, the data collection during the last stream surveys completed in the late 1990s and early 2000s appear to indicate the beginning of a recovery. No data is available from 2005 to present to quantify the current population, but anecdotal evidence and general sentiment of the community indicates low overall escapement.

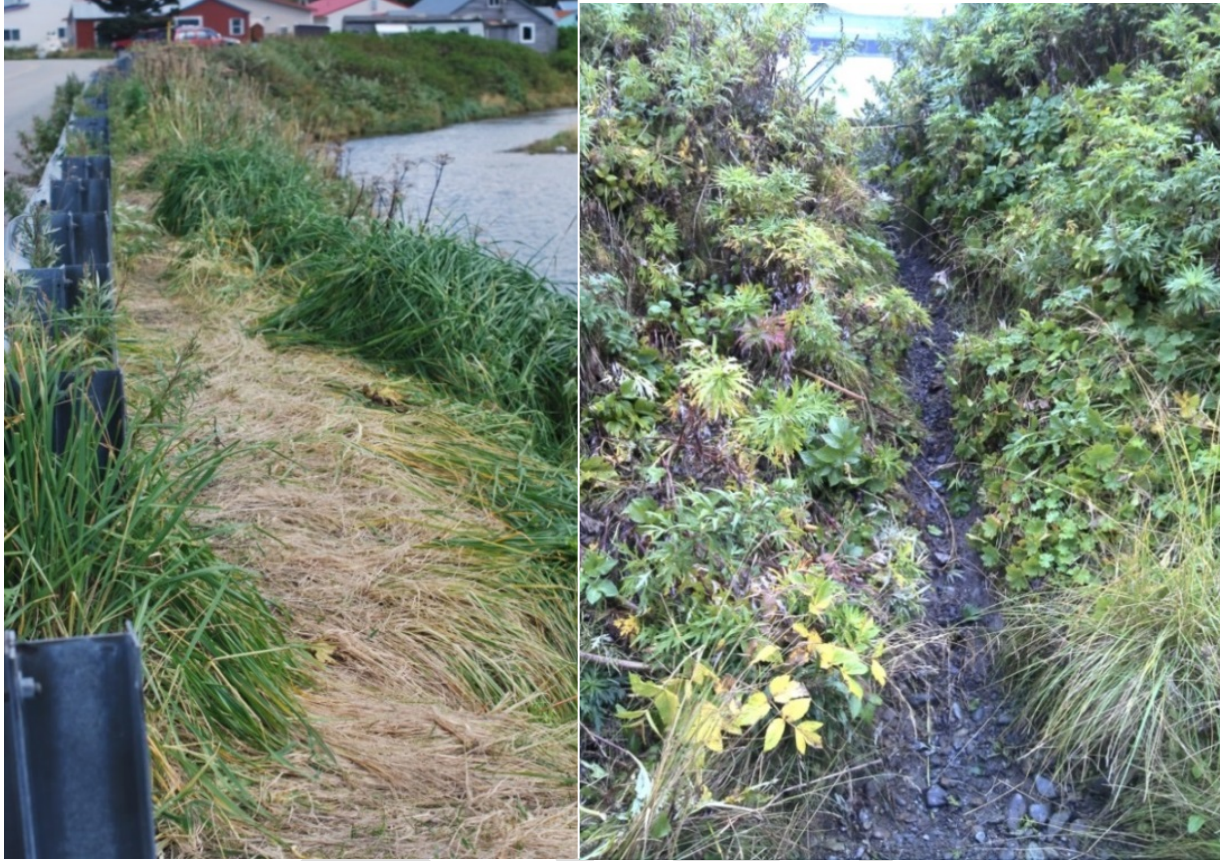
Photo 2-2. Left: Trampled Vegetation along Guardrail; Right: Noted Erosion on Upper Riverbank due to Surface Drainage

Through the September reconnaissance visit, observations were made regarding areas of primary access, overall use of the lower river, erosional issues, and presence of classified wetlands. Primary access appeared to occur around homemade floats and docks and also concentrated at openings in the guardrail down to the river. This was noted through well established pathways of trampled grass or areas with lack of vegetation (see Photo 2-2, left and Photo 2-3). Photo 2-2 (right) displays erosion likely due to uncontrolled surface drainage discharge from the adjacent road. Overall use of the lower river appeared to be focused on salmon fishing and gaining access to docks and floats. Salmon fishing is only legal downstream of a sign located within the lower 1,500 feet of river and is closed to sockeye fishing throughout the watershed.

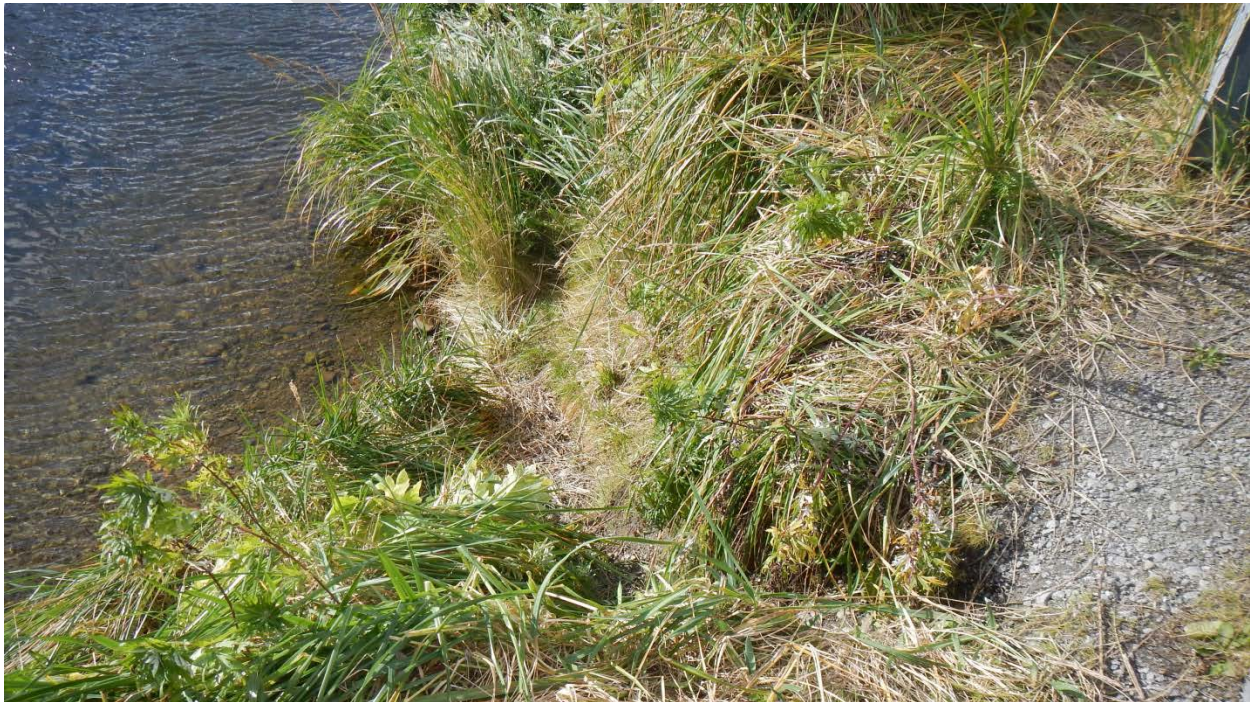
Photo 2-3. Noted Erosion along the Banks of the Lower Iliuliuk River due to Foot Traffic

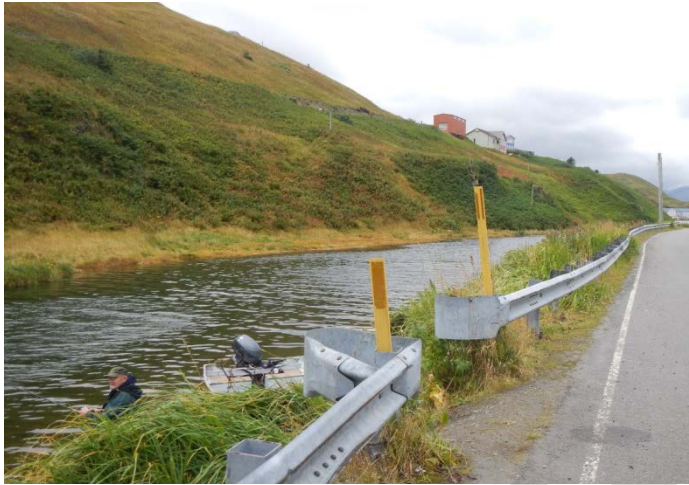
Photo 2-4. Fishing along the Lower Iliuliuk River near Opening in Guardrail

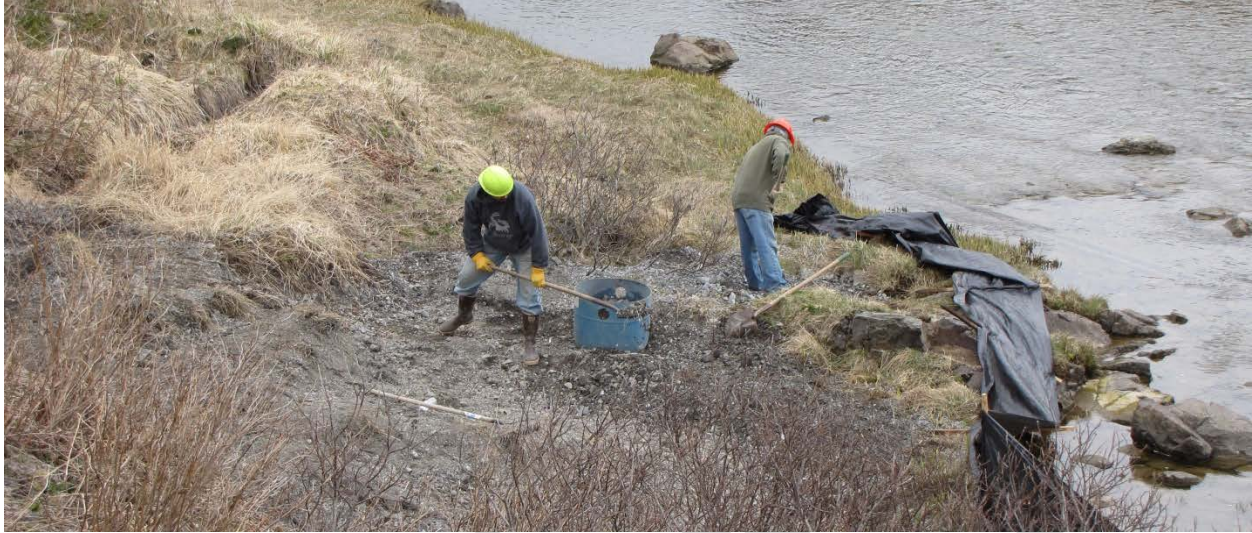
Photo 2-5. City Roads Crews Cleaning up Snow Dump along South Bank of the River

into the river. Snow piles that accumulate throughout the winter along the river can contain large amounts of gravel and other potential pollutants that will drain into the river each spring. Photo 2-5 displays the City Roads crew cleaning up a snow dump on the south side of the Iliuliuk River.

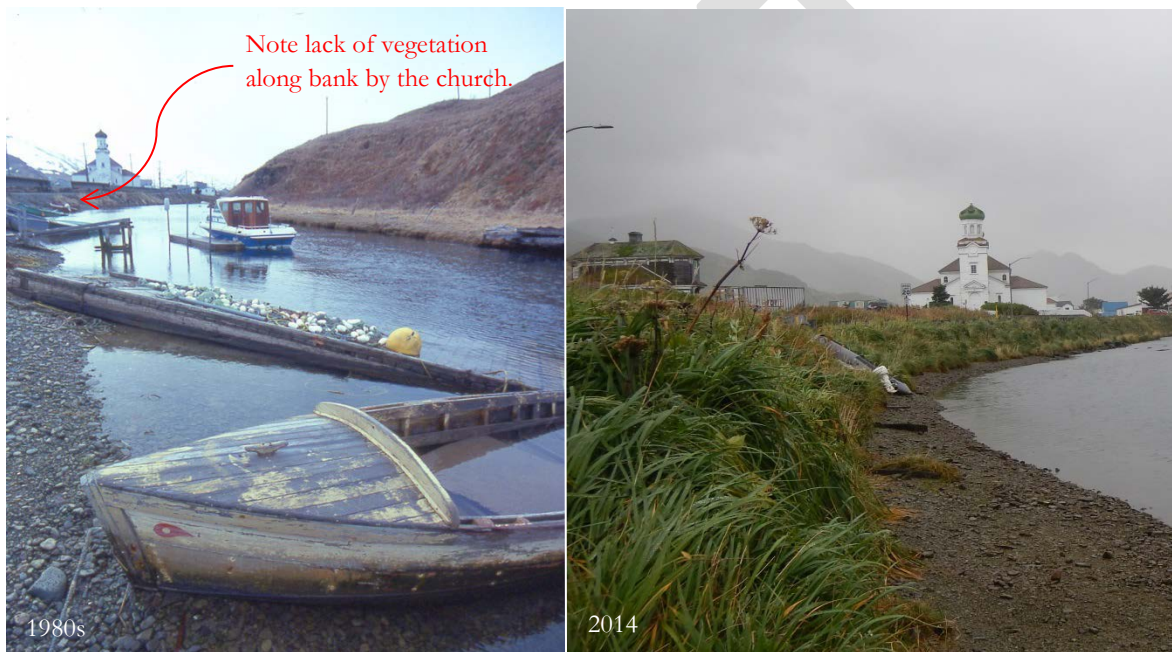
Photo 3-1. Left: Bank Photo from 1980s; Right: Bank Photo from 2014

As noted in the attached wetlands delineation report, the majority of vegetation along the north bank of the lower river consisted of beach wildrye, and soil generally consisted of gravel road fill. Over time, vegetation has naturally started taking hold of the bank. Community member comment and historical photography supports this conclusion. As recently as the 1980s, very little area on the banks had healthy growing beach wildrye. The site visit in 2014 displayed a much wider area of vegetation with some wetland areas. See Photo 3-1.

This suggests that the hardy beach wildrye grass will eventually begin to take hold on its own. Revegetating areas with lack of grass will speed up this process, and in turn, immediately provide some protection in areas that are eroding.

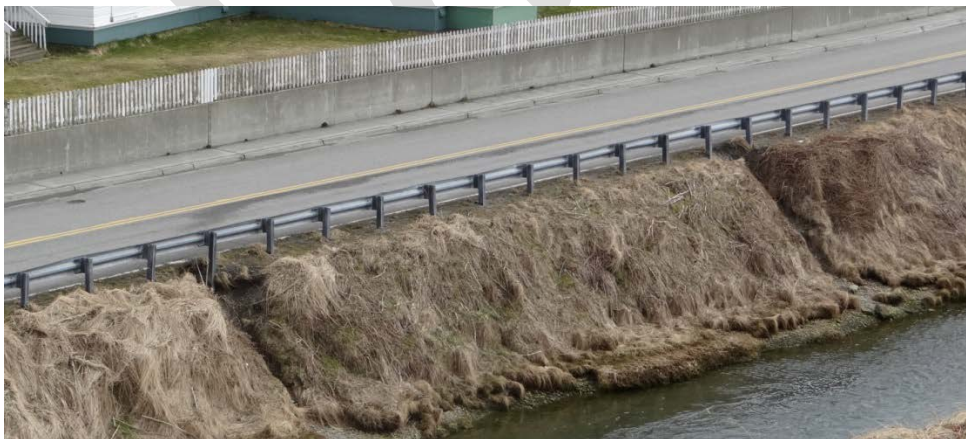
Photo 3-2. Erosion from Runoff Threatening Roadway

Additional erosion prevention, not addressed in the grant, would require addressing drainage issues from the north and south sides of West Broadway Avenue. Several areas of erosion are threatening the road. During rain events, surface water drains over West Broadway Avenue's pavement and finds the lowest spot along the north bank. In some locations, the erosion is abutted or even has undermined the existing pavement structure. Some of these areas of notable erosion due to uncontrolled runoff are displayed in Photo 3-1(right) and Photo 3-2. An option for addressing this issue could include placement of riprap on top of the current eroded area. This would slow down runoff and protect the underlying soil from future erosion. Revegetation of beach wildrye could be incorporated into these areas as well.

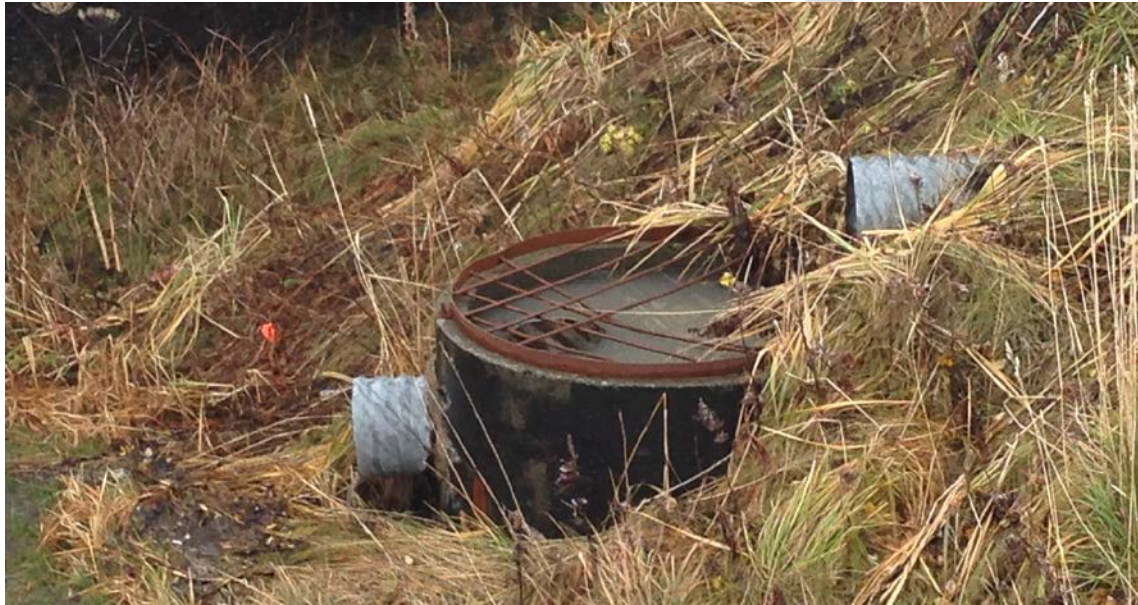
Photo 3-3. Outfall Sediment Collection System near 5th St. Bridge

The lower river is also subject to sedimentation. Storm drains can capture sediment throughout their runoff path and discharge the sediment into the lower river at an outfall. A settleable solid collection system at the outlet of the storm drain system could help collect the sediment, reduce stream bank erosion, and allow for easier maintenance and cleanout of the system where workers could flush out the storm drain without discharging directly into the river. This could be accomplished through installation of precast concrete barrel sections at the outlet of multiple culverts along the lower river. One of these structures is in place adjacent to the 5th Street Bridge as shown in Photo 3-3.

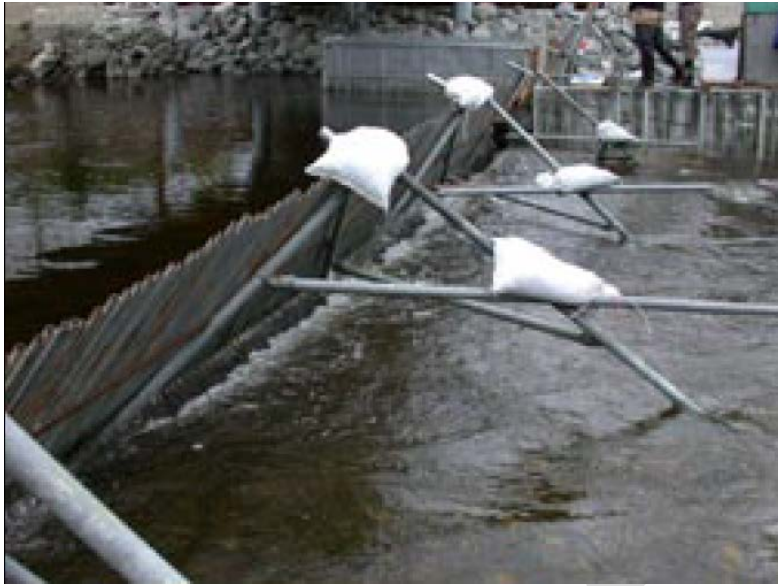
Photo 3-4. Rigid Tripod Weir Example (Zimmerman & Zabkar)

A rigid weir, or tripod weir, would be installed across the river, and semi-fixed to the stream. These weirs can be constructed out of varying materials, such as PVC pipe or aluminum pickets, screen or wire panels, and netting. Pickets are strung together and angled at 120 degrees from the streambed to allow pressure dissipation from the water, and are held in place by tripods constructed of pipe, such as electrical conduit. See Photo 3-3. These rigid weirs require a somewhat steady water surface elevation in order to work properly.

The rigid weir is removable, and can require a significant amount of maintenance. The rigid pickets across the stream tend to pick up debris, leaves, and algae, which clog the weir from water movement. This can create an elevated amount of pressure behind the weir leading to blow out. The panels need to be cleaned often. Additionally, during storm events, or high water, the entire weir can become damaged and carried downstream.

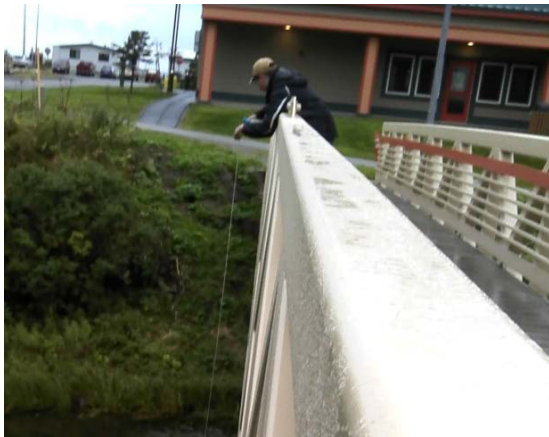
Photo 4-1. High School Student Measuring Transparency of the Water

Lake watershed and Iliuliuk River. Photo 4-1 shows a high school student conducting turbidity measurements on the Iliuliuk River near the 5th Street Bridge.

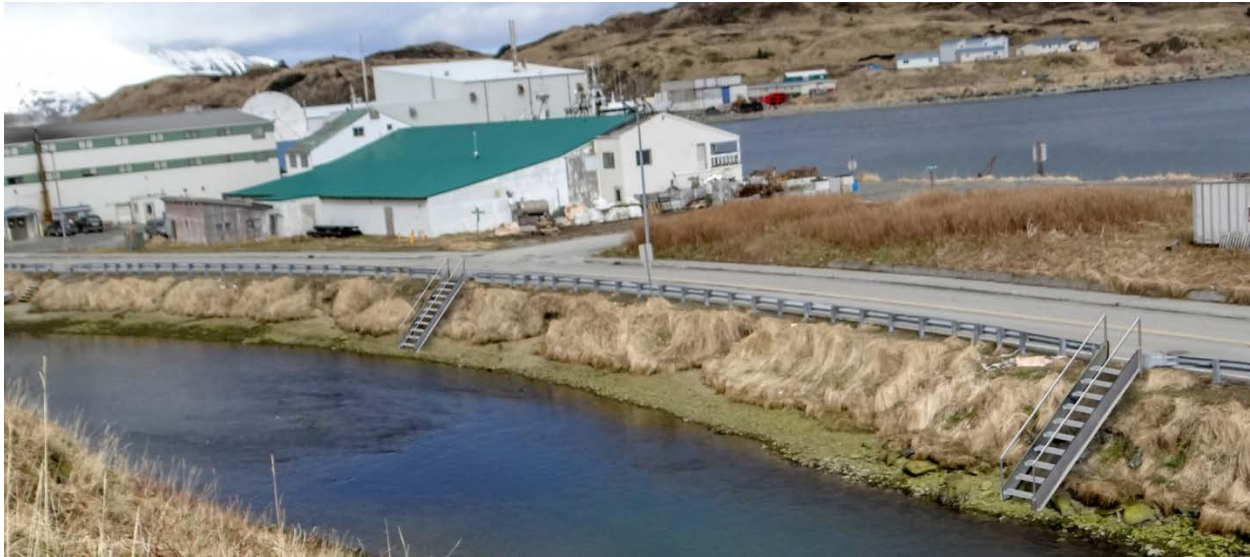
Figure 5-2. Rendering of Light Penetrating Stairways

Installation of light penetrating stairways would need to take place during the summer/fall of 2015. Procurement should take place as soon as the restoration measures are decided, and construction (such as drilling stair pile) should take place during early summer (within allowed fish windows if piles are within the water) in order to allow for any necessary revegetation in the disturbed area to take place afterwards. A rendering of light penetrating stairs at openings in the guardrail is shown in Figure 5-2.

Maintenance of the stairs would include inspection and repair of any defects that could create a public safety hazard. Additional maintenance would be needed to make sure the stairs are clear of debris that would block the light penetration to the vegetation below.

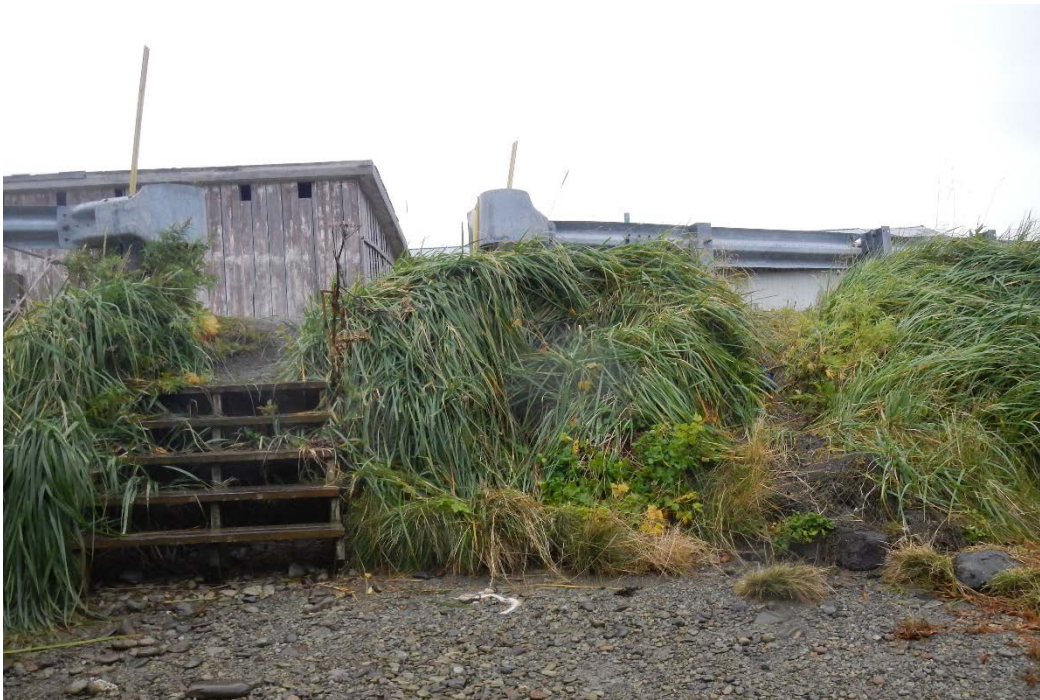
Picture 1. River access stairs and impacted vegetation area.

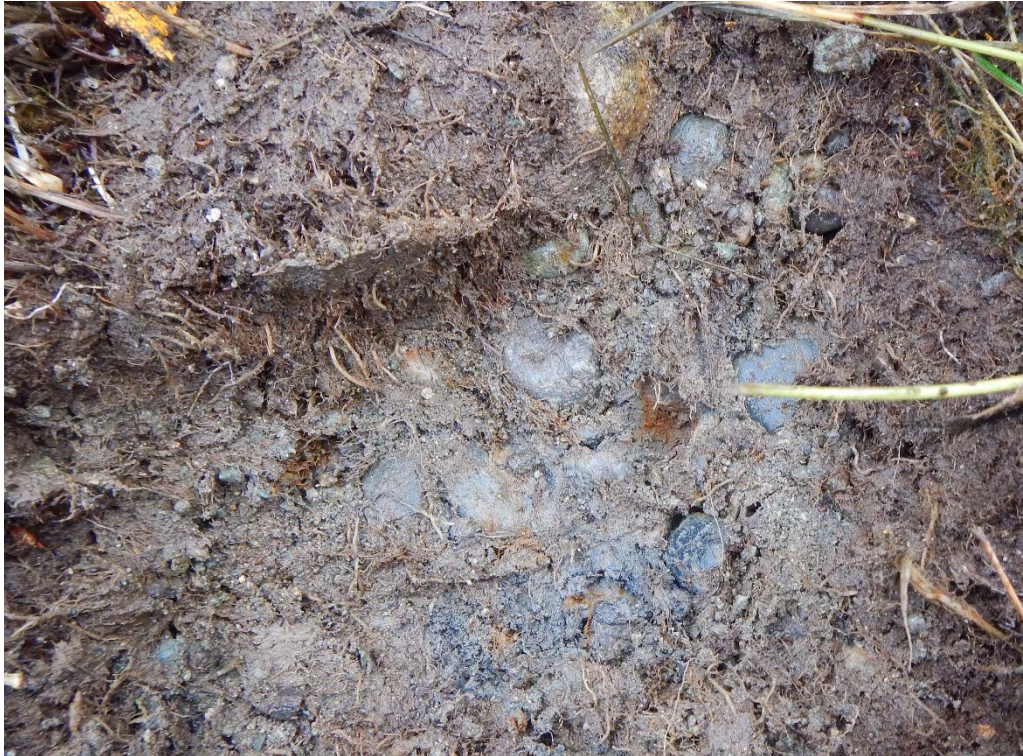
Picture 2. Presence of gleyed soils and iron deposits at TP 1.

Soils in this wetland were topped with a vegetative mat. Below the vegetative mat, only 3 inches of soil occurred before dense gravel and cobbles (streambed materials) were encountered. The soils at TP 1 contained iron deposits occurring throughout the gleyed matrix seen in the following picture.

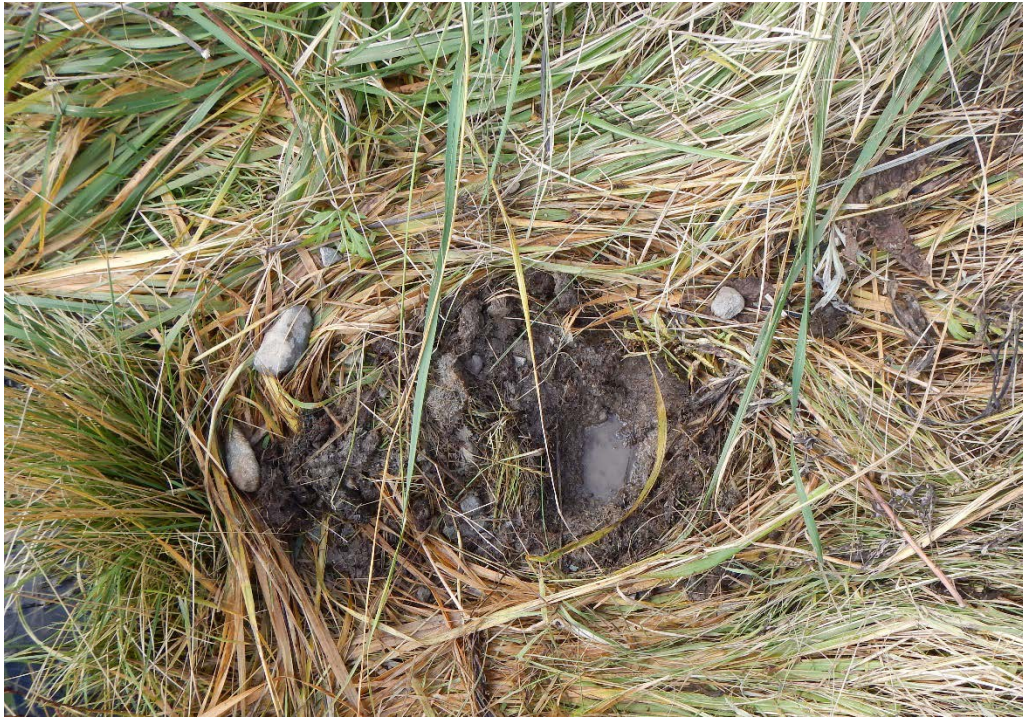
Picture 3. Presence of high water table within wetlands at TP 1.

Soils exhibited saturation at TP 1. During the high tide, the TP also exhibited a high water table as evidenced in Picture 3 below.

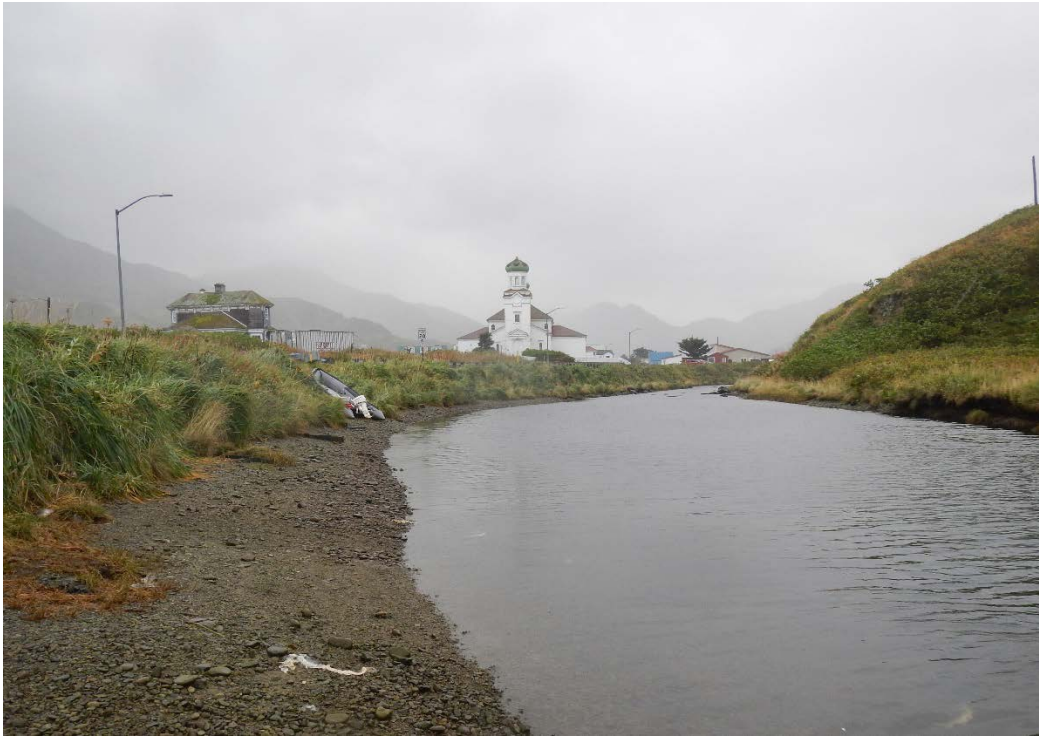
Picture 4. River at low tide.

The lower Iliuliuk River within the project area was determined to be a tidal riverine wetland due to the tidal influences from Iliuliuk Bay on the river. During low tide periods, the rocky streambed could be seen along the river's edge. The streambed that remained underwater was assumed to include patchy cobbles due to the streambed conditions 50-100 feet upstream of the project boundaries. There were few wetland plants in this portion of the project area and the site was assumed to be wetland although wetland plants were not fully assessed.

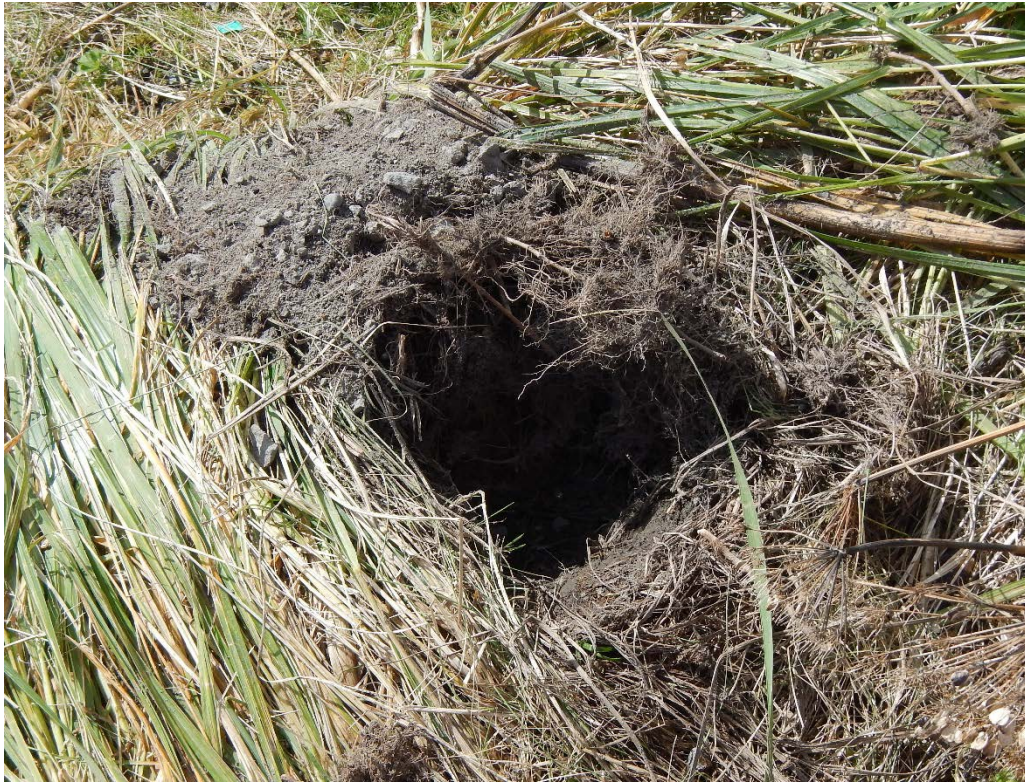
Picture 5. Dry upland soils at TP 2.

The sloping land along the lower Iliuliuk River project area was mainly covered with beach wildrye (*Leymus mollis*) with small amounts of seabeach senecio (*Senecio pseudoarnica*) and seacoast angelica (*Angelica lucida*) present, and even smaller amounts of sedge and arctic bluegrass (*Poa arctica*) present. The texture of the soils within the upland habitat was sandy loam. Soils in the upland TP (2) did not exhibit saturation as evidenced in picture 5 below. Hydric characteristics were not present in soils in TP 2. Soils at TP 2 felt dry, although they were slightly moist due to recent rain events. Upland areas appeared to be filled with gravel beginning 7 inches below ground surface. It is likely that this area was filled for the construction of West Broadway Avenue, but aerial photograph and available resources could not confirm.

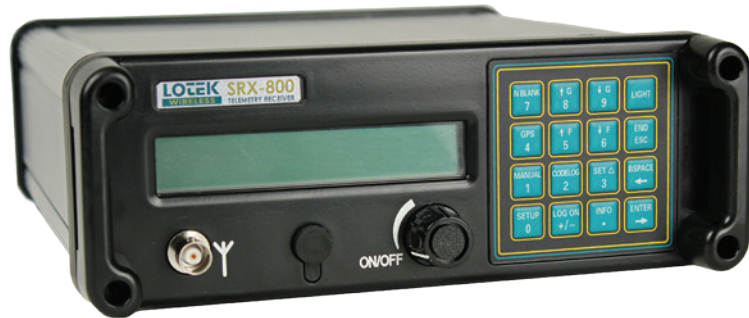
VHF Radio Receiver

The Lotek SRX-receiver remains the telemetry instrument of choice for tracking fish, wildlife and birds within their natural environment since 1991. SRX 800 inherits reliability and sensitivity from predecessors SRX 400 and SRX 600, with additional features,

such as simultaneous beeper and coded transmitter tracking, and new, weather resistant packaging. Best of all, affordability has been significantly increased without sacrificing quality. The SRX 800 is the latest standard on which to base your next telemetry project.

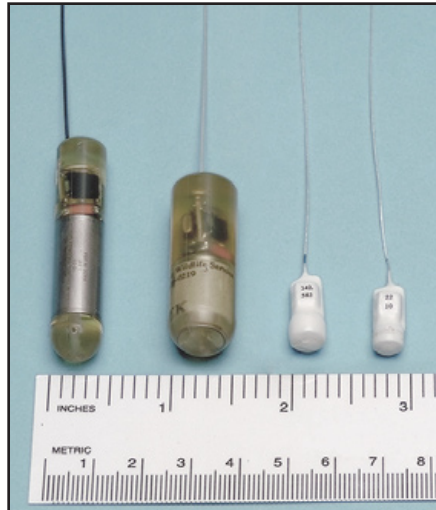
Coded Radio Transmitters

MCFT2 Series radio transmitters are designed for operation in Lotek digitally encoded telemetry systems. Based upon a proprietary coding scheme, these systems allow up to 521 transmitters on a single frequency, while retaining the ability to identify individual animals.

This capability significantly reduces the need for additional frequencies, with a corresponding reduction in total scan time over conventional pulsed systems. Spatial and temporal resolution is enhanced accordingly.
